NCEL

Technical Note

September 1986

Corrosion and Corrosion Control of Hush House Interiors

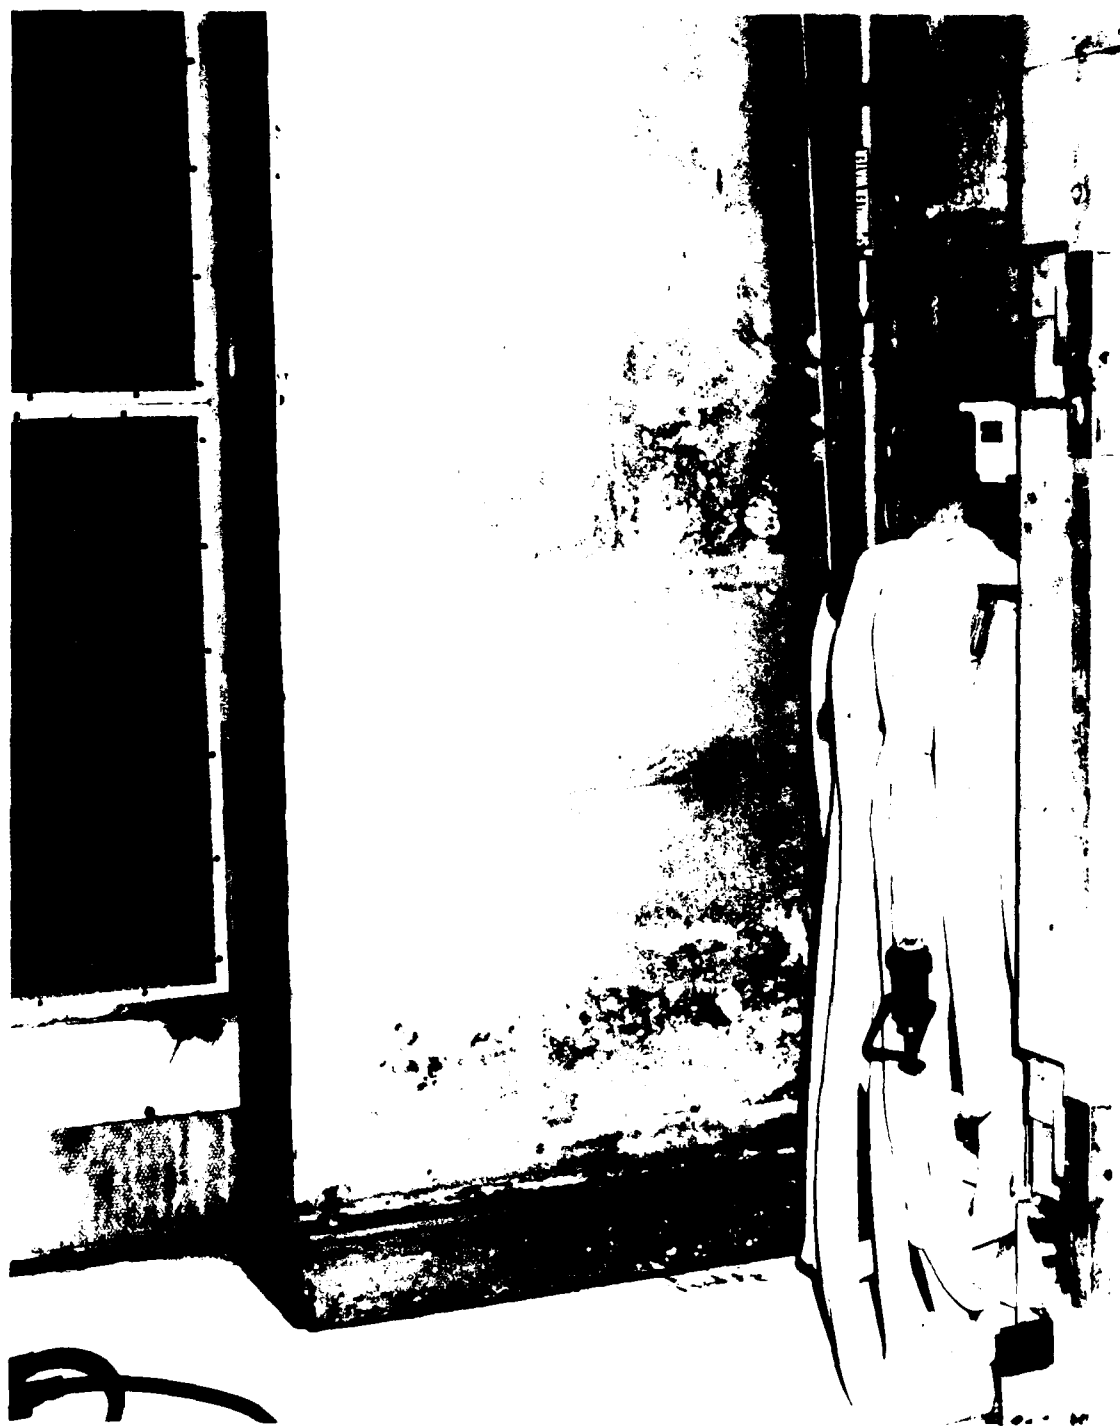
In June 1983, the exterior of the perforated liner plate was inspected. The corrosion damage was widespread. As shown in Figure 2, it was generally concentrated at the lower portions of the sections and, to a lesser extent, at an area approximately 4 feet above the bottom of the sections. The corrosion damage, which ranged from a light covering of white corrosion products to red rust, was typical of galvanized steel exposed to a rural-type exterior atmosphere. The areas of most severe corrosion damage were adjacent to the firefighting hose and to the hose bibs on the two lateral walls. Above the 8-foot level there were scattered areas with a very thin layer of white corrosion products.

Figure 2. Example of liner corrosion at lower section near fire hose.

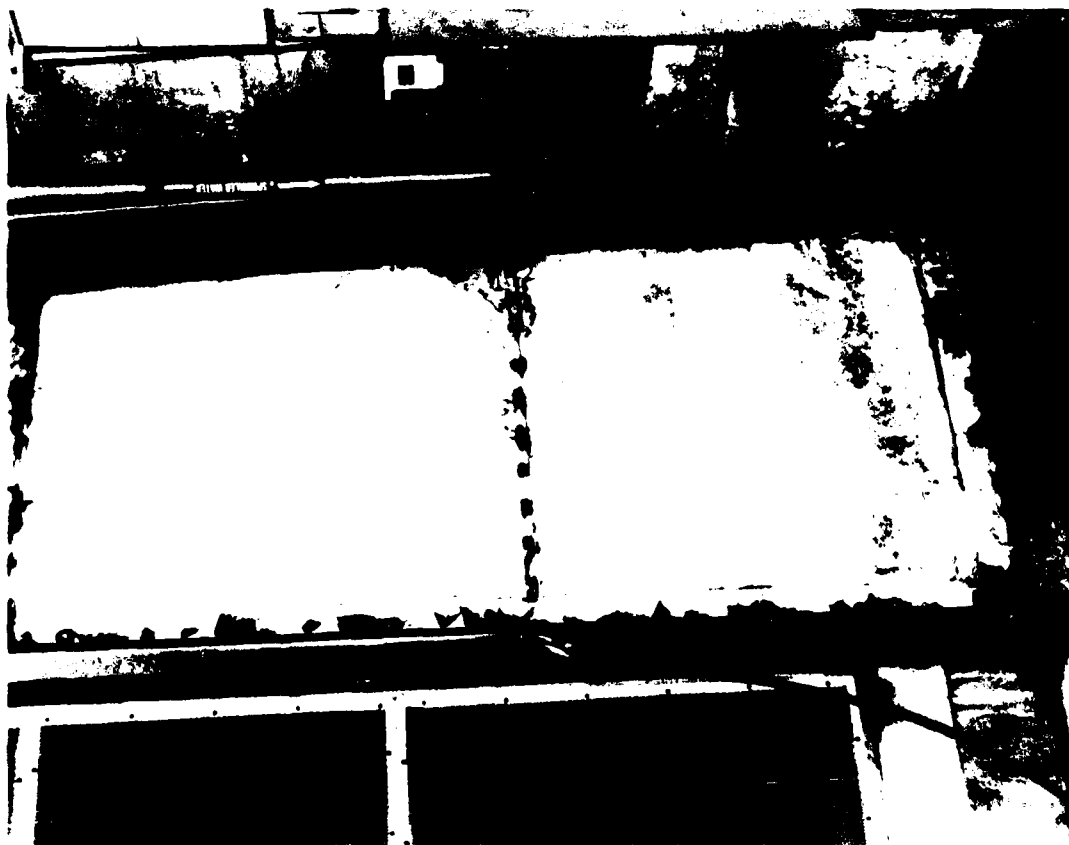
After all of the welds had been cut, the panel was removed and the acoustic material was exposed and inspected. As shown in Figure 6, the fiberglass material was stained. As shown in Figure 7, the material in the first layer of insulation was inspected for moisture before removal and was found to be dry to the touch. The fiberglass cloth covering the outer section of the acoustic material was, however, water stained. The outer section of the acoustic material was removed and unwrapped. The lower section of the material was significantly deteriorated, and it easily crumbled when handled as shown in Figure 8. The inner section of acoustic material was then removed. Portions of this material adhered to the interior plate of the section (see Figure 9) but were easily removed by light scraping. The acoustic material was retained for future evaluation in a separate work unit.

Figure 6. water stains on fiberglass covering.

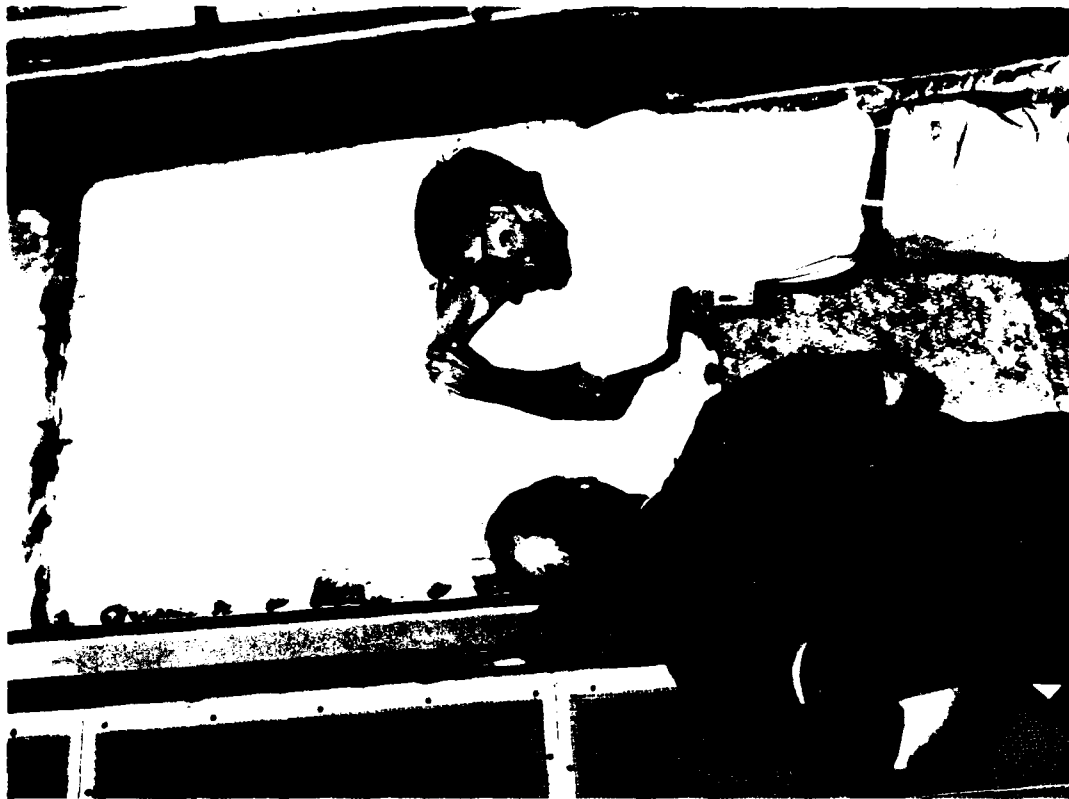
Figure 7. Inspection of acoustic material for moisture.

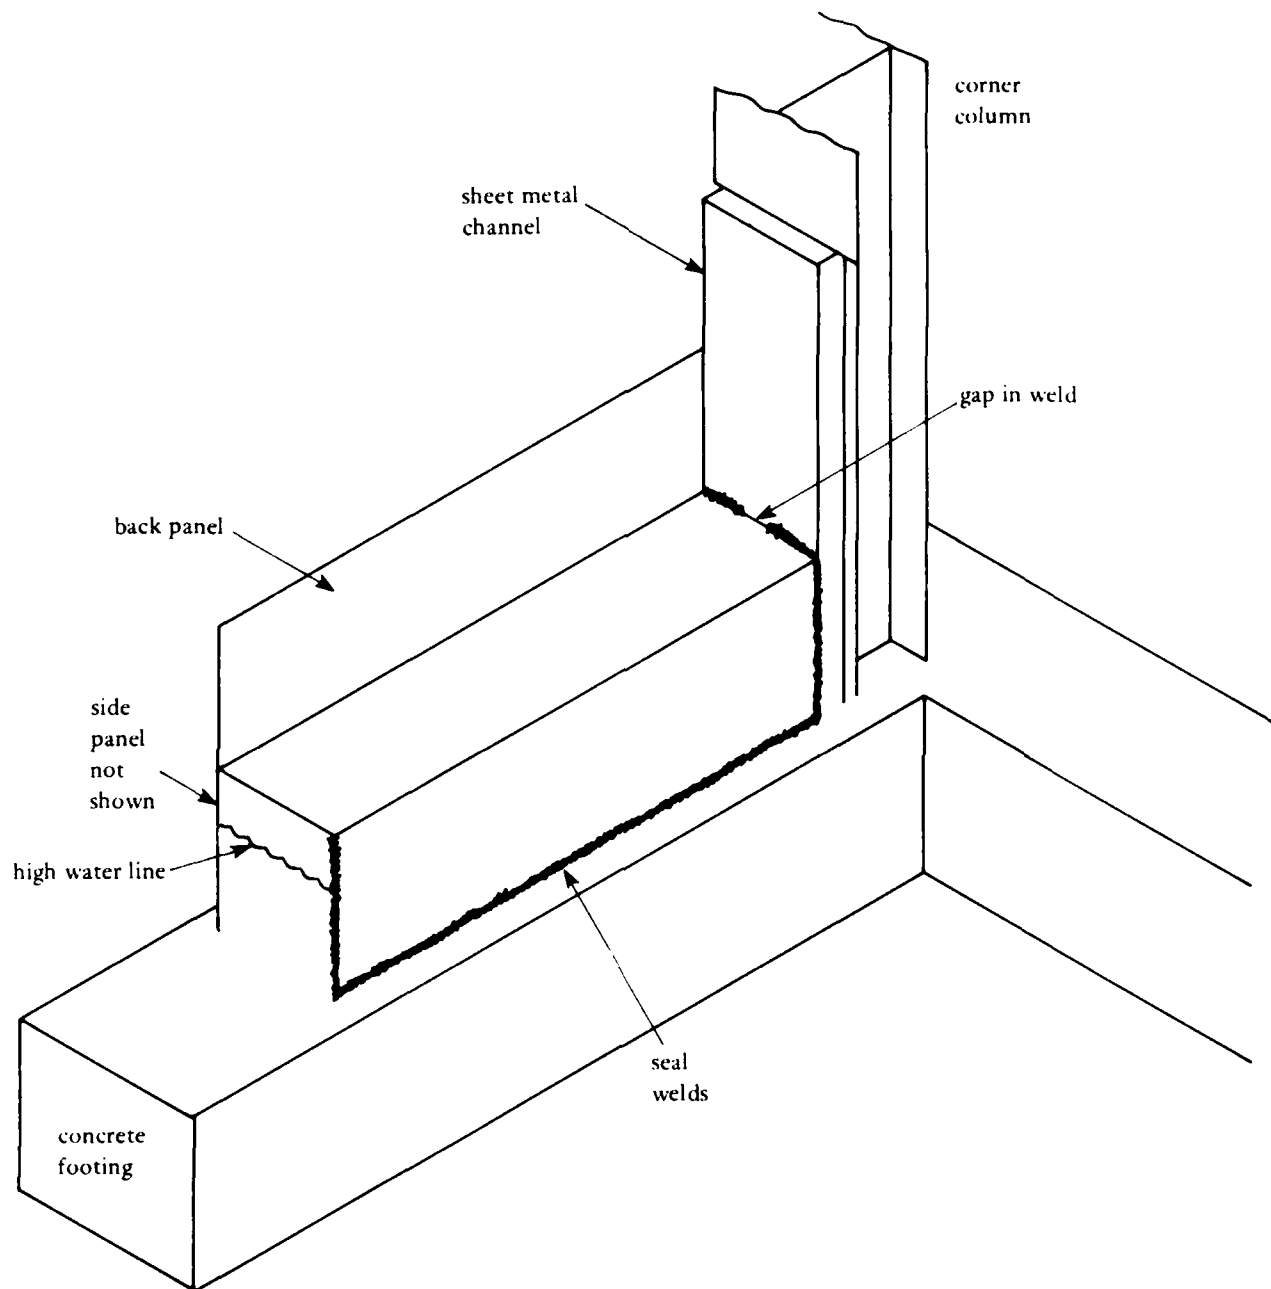
Figure 18. Sketch of lower support channel showing water entrapment mechanism.

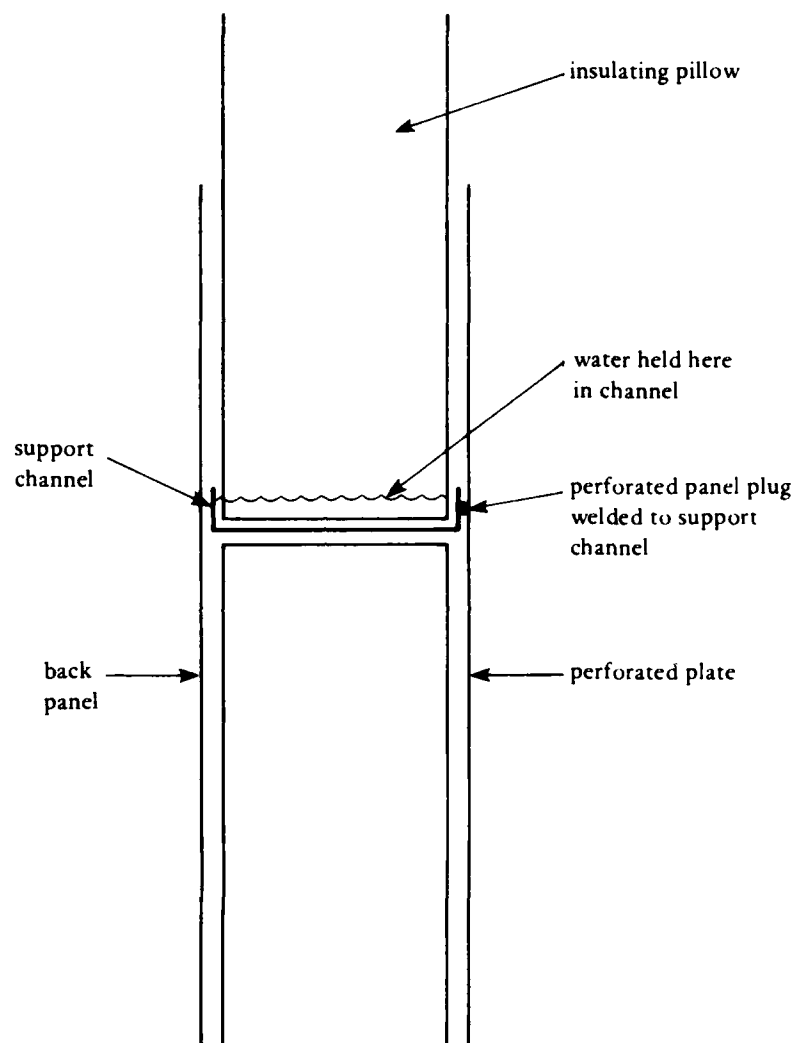
Figure 20. Sketch of midspan support showing water entrapment mechanism.

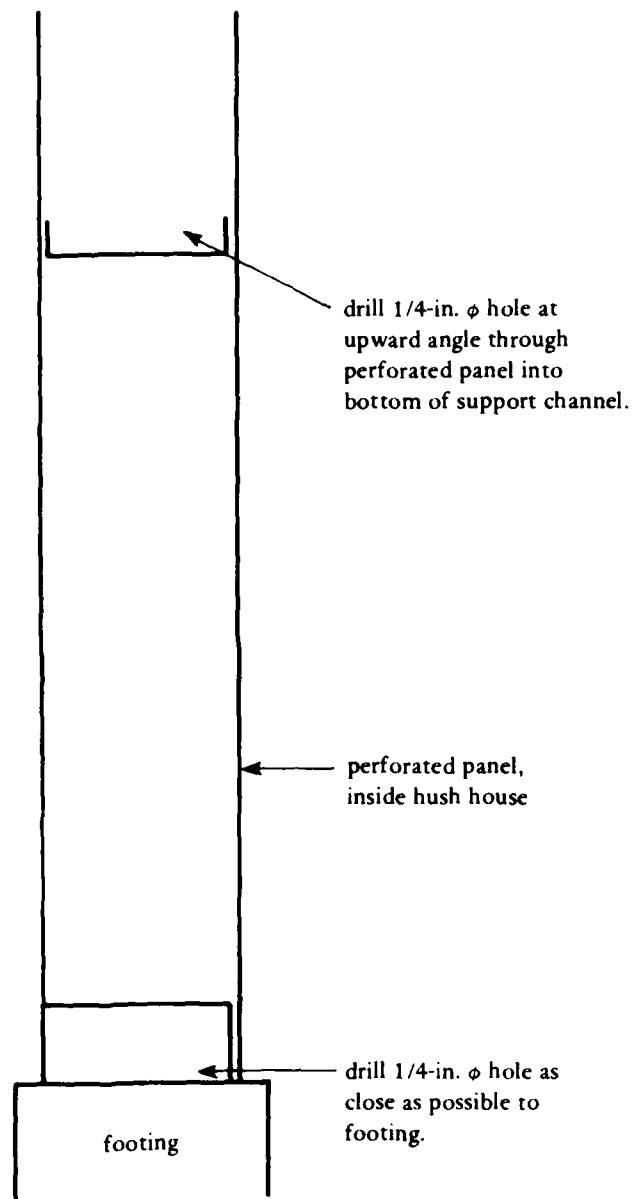
Figure 27. Recommended drainage points.

1. Where corrosion is visible on the interior surfaces of the hush house, the extent of damage should be assessed by visual examination and ultrasonic thickness measurements.
2. The potential for wetting of the interior of the hush house during routine operation or cleaning should be eliminated by modifying either the facility or the procedures.
3. As shown in Figure 27, sections where water could be trapped should be drained by drilling drainage holes as noted.
4. The lower sections of the interior should be cleaned and coated as described previously to achieve a uniform finish.
